UNITED STATES ENVIRONMENTAL PROTECTION AGENCY
REGION 2
290 BROADWAY
NEW YORK, NY 10007-1866

Re: Phillips 66 Co., Bayway Refinery, Linden NJ
EPA/NJDEP NJPDES Permit Compliance Evaluation Inspection June 12, 13, and 20, 2019
NJPDES Permit No. NJ0001511 (NJPID No. 46318), NJ0026671 (NJPID No. 46322)

Enclosure – Inspection Report from June 2019 CEI

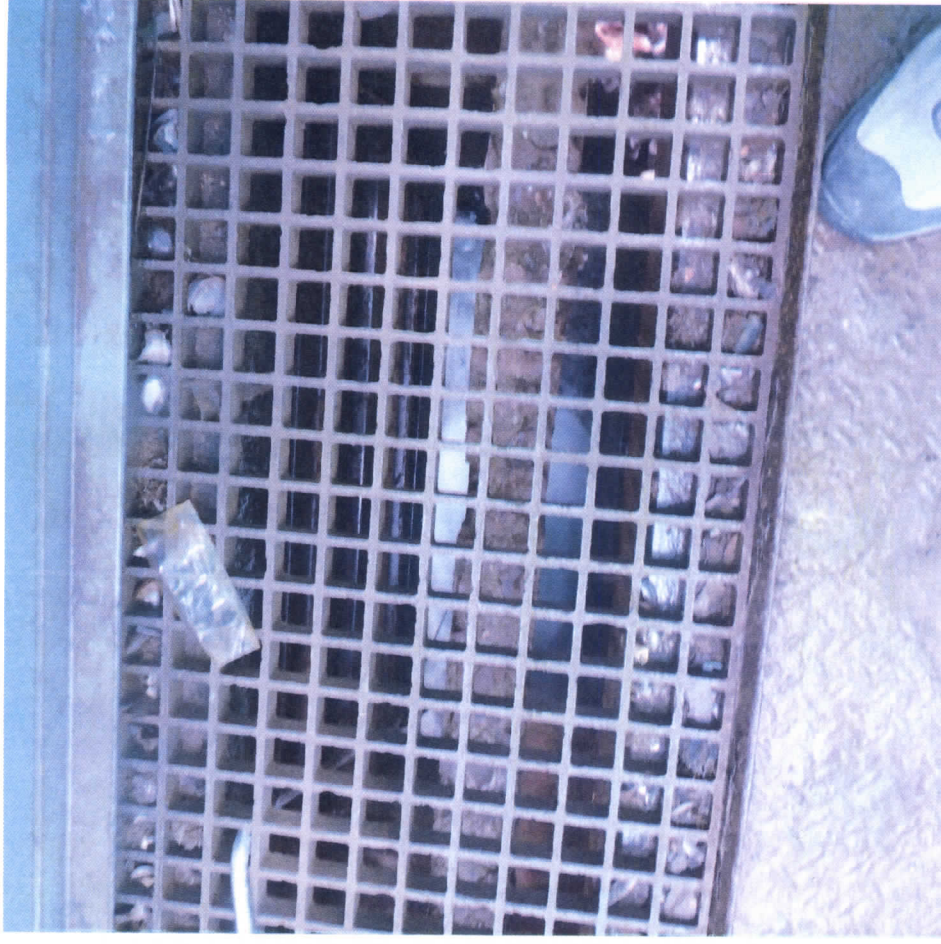
DSCN6877 – impinged shellfish collected in crate next to
Arthur Kill pump house screens

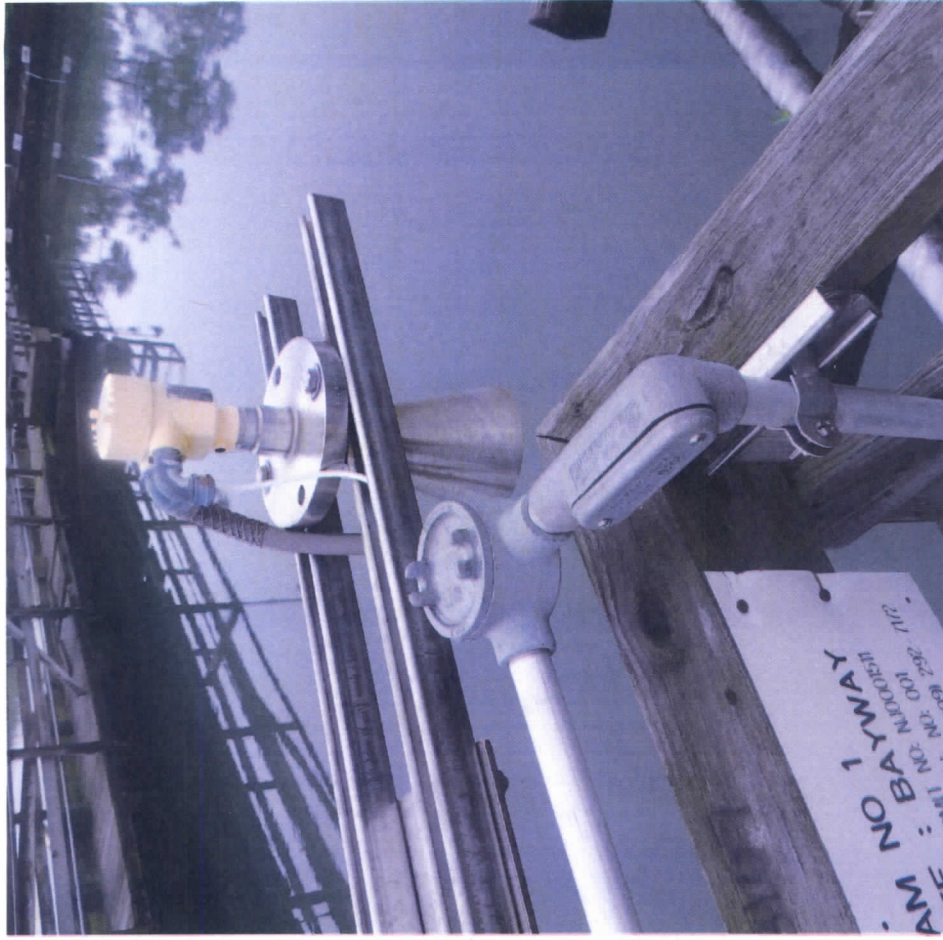
DSCN6888 - oil sheen on surface of water just prior to discharging thru the sorbent booms and underflow weir and prior to discharging from Outfall 001

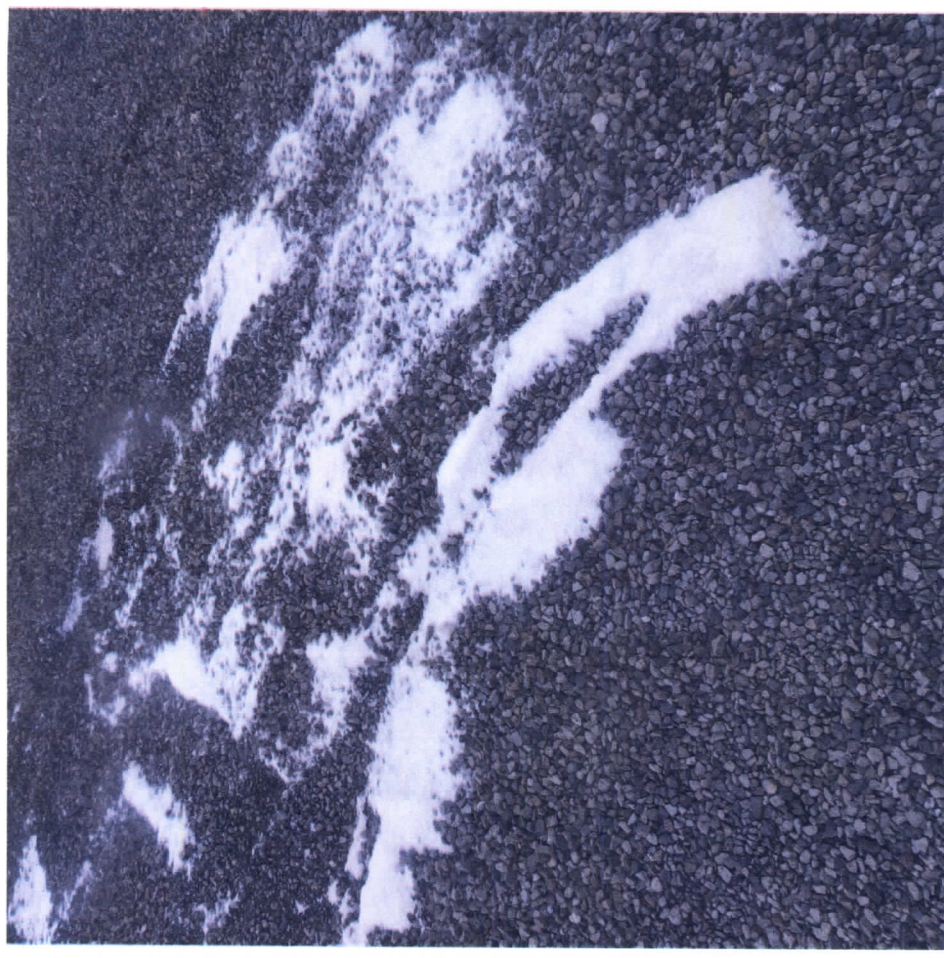
DSCN6902 - Polypropylene pellens on ground near
polypropylene area.

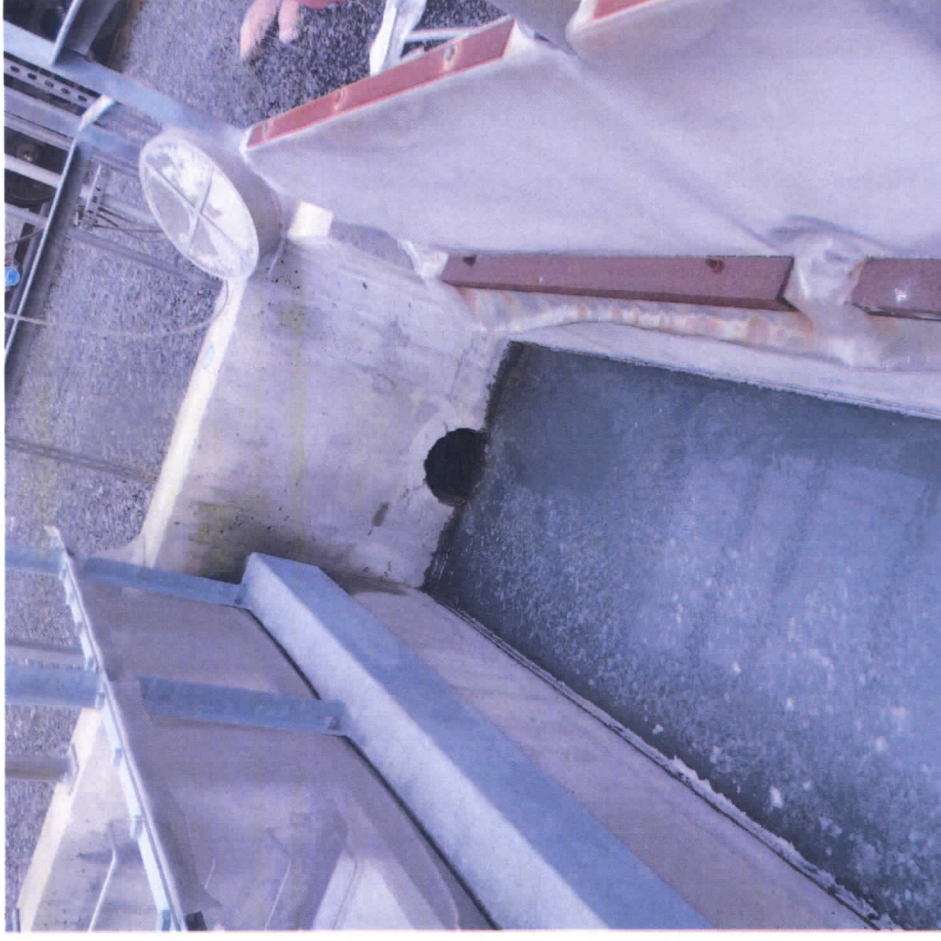
DSCN6904 – effluent end of polypropylene area separator
discharging floating pellets to Outfall 005

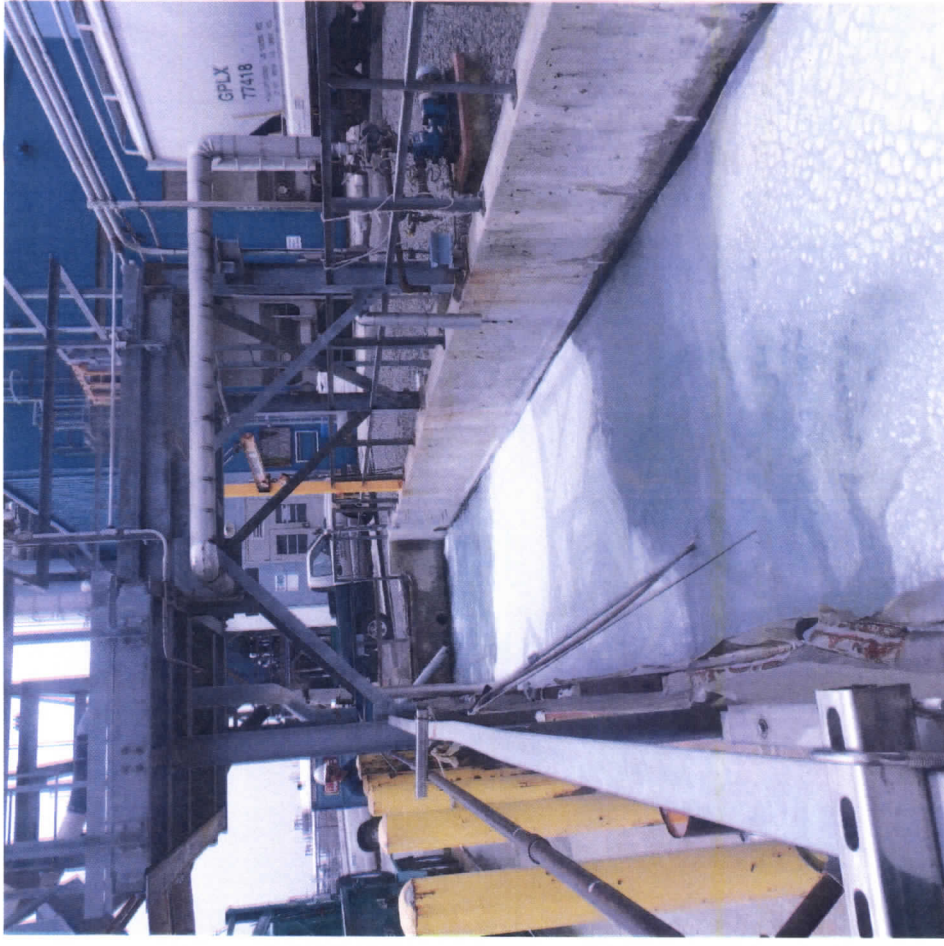
DSCN6906 - effluent end of polypropylene area separator discharging floating pellets to Outfall 005 – Outlet pipe cover not on outlet –but on wall.

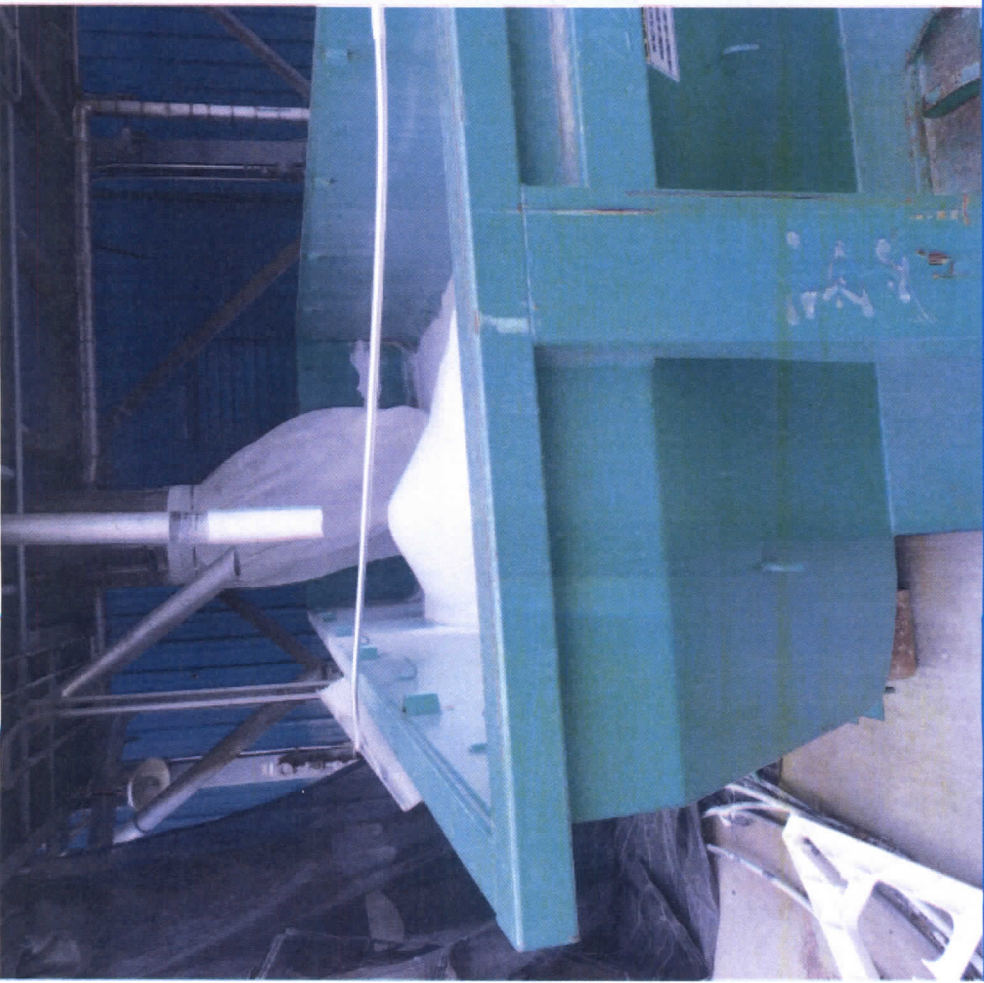
DSCN6912 – valve in polypropylene separator area.

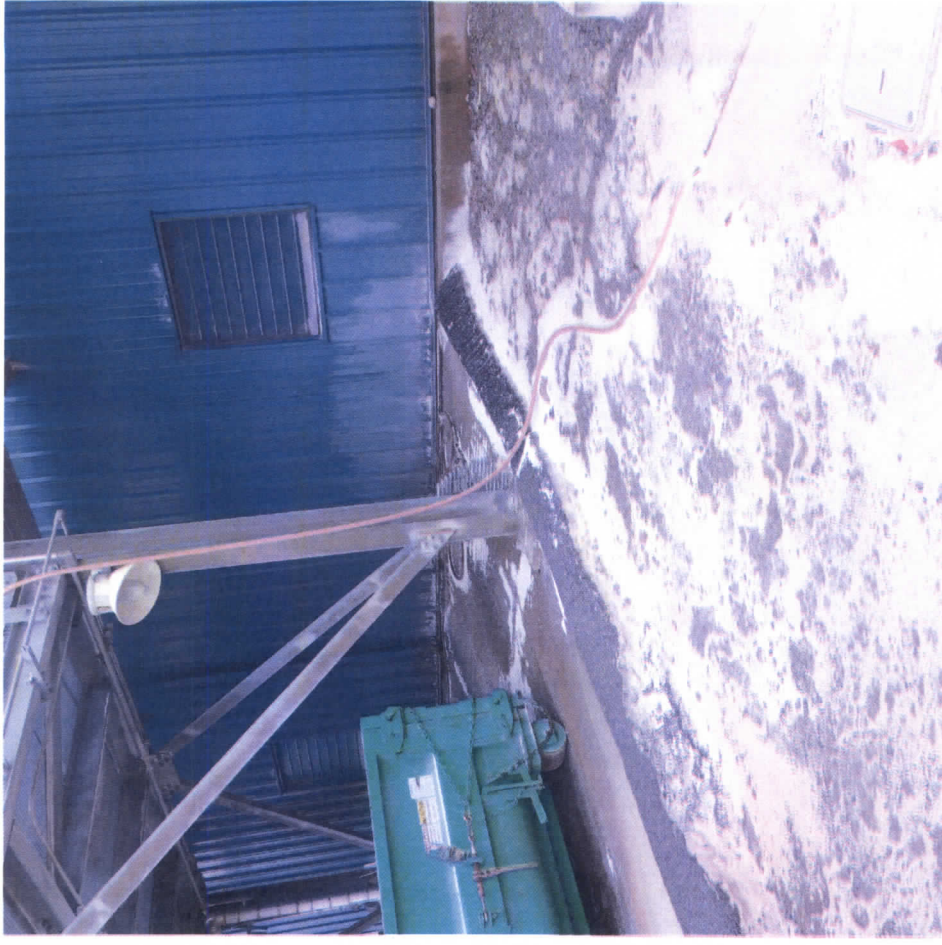
DSCN6915 – polypropylene baghouse dumpsters

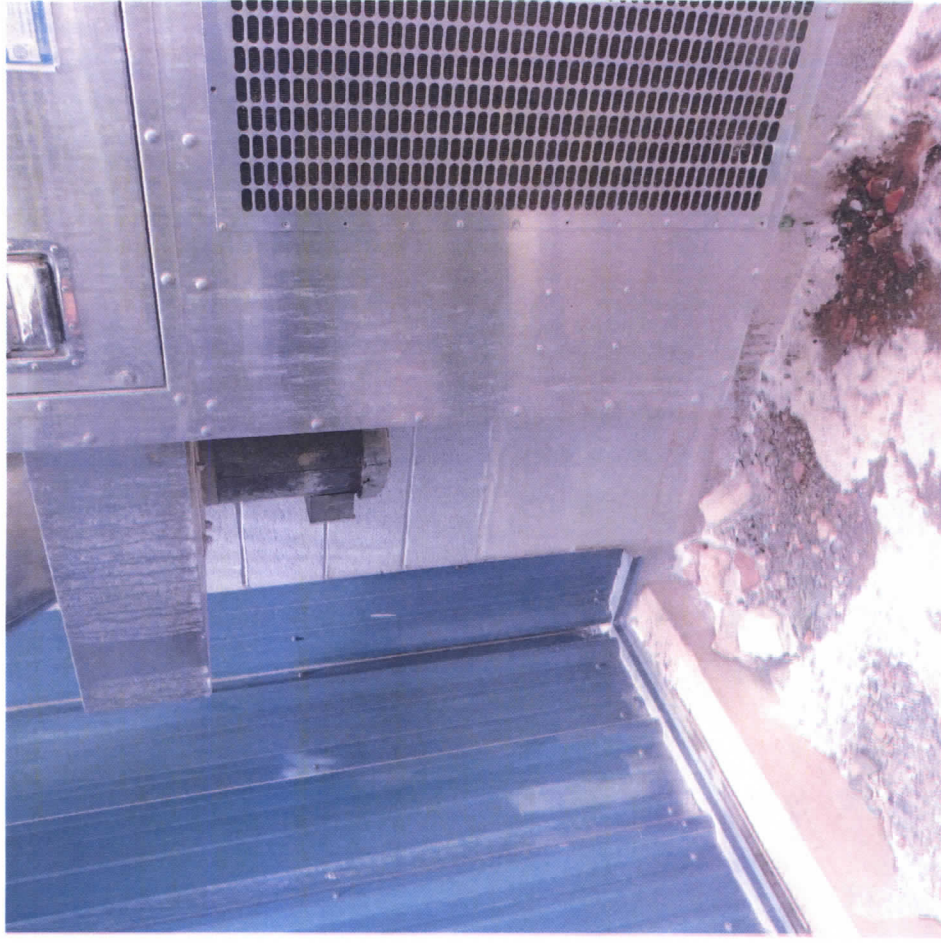
DSCN6919 - Polypropylene pellets on ground near air intake for Conditioner Unit

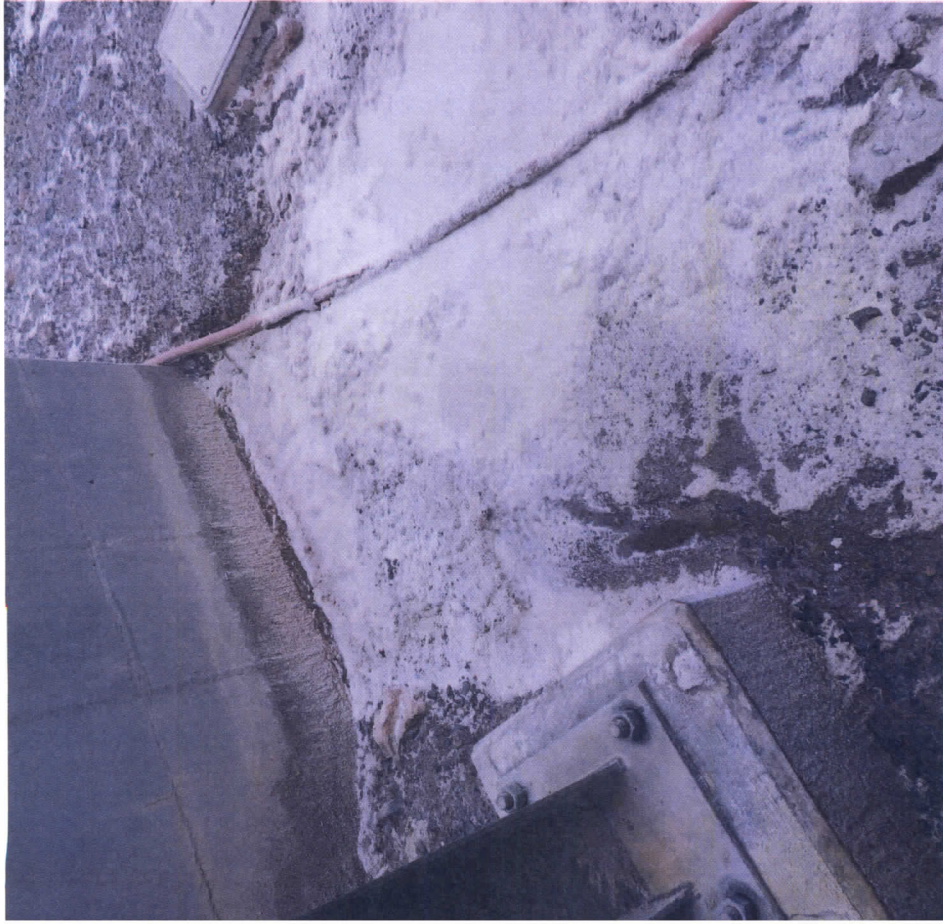
DSCN6920 - Polypropylene pellets on ground near air intake for Conditioner Unit

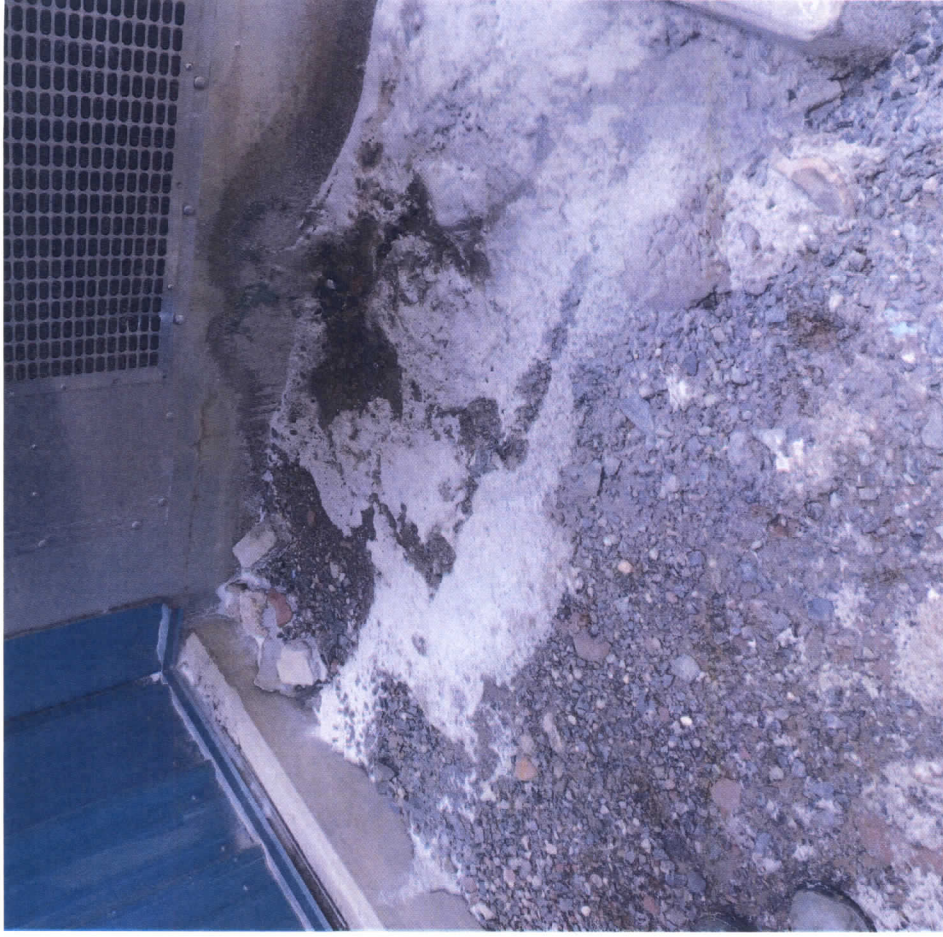
DSCN6921 – Polypropylene pellets on ground near air intake for Conditioner Unit

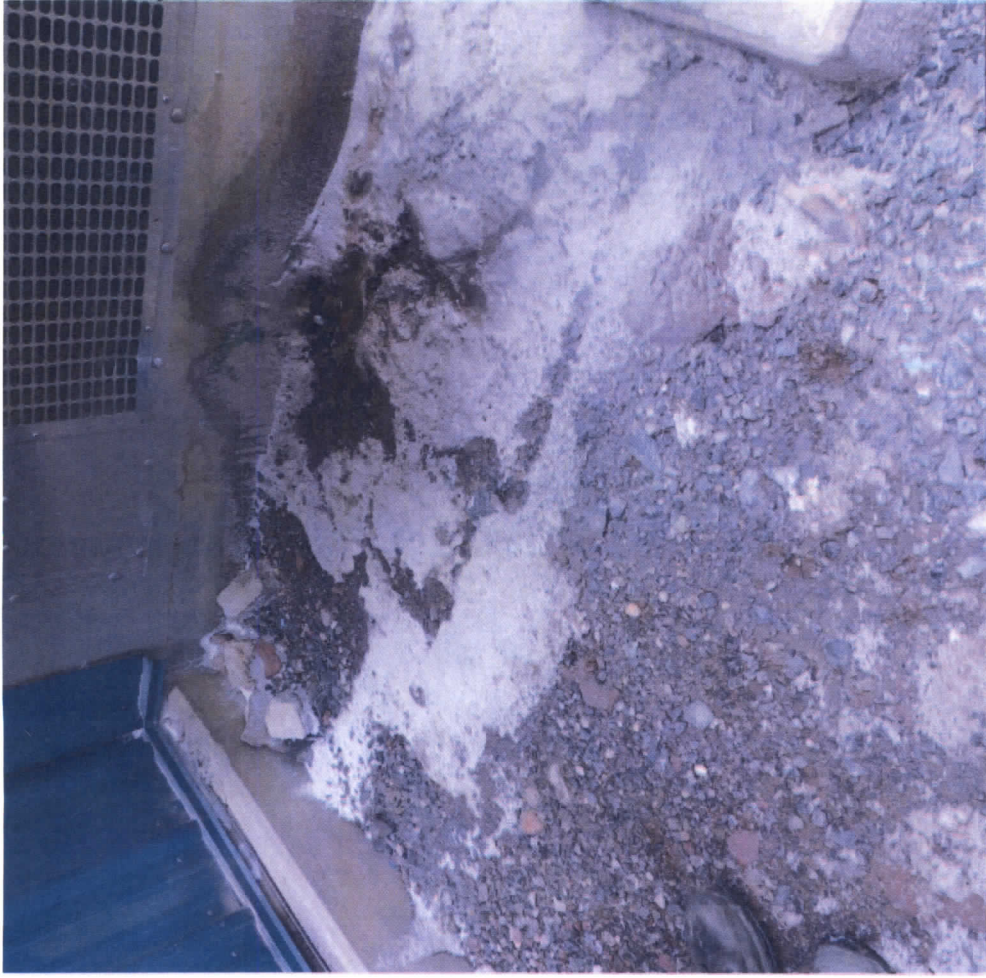
DSCN6922 - Polypropylene pellets on ground near air intake for Conditioner Unit

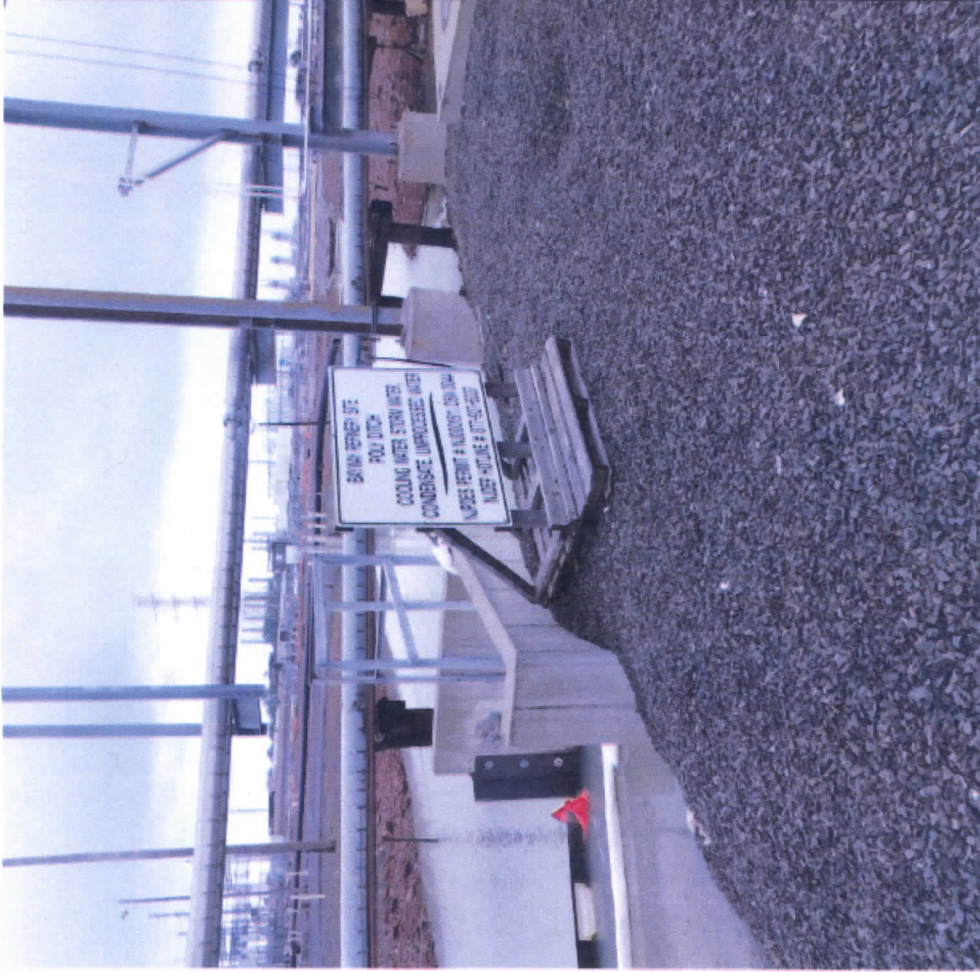
DSCN6928 - Overflow of ISO Unit onto ground – said that it flows to the process sewer
